4 WARRINGTON DAM, BUCKS COUNTY
PENNSYLVANIA

5
6 PHASE I INSPECTION REPORT
NATIONAL DAM INSPECTION PROGRAM.

PHASE I INSPECTION REPORT
NATIONAL DAM INSPECTION PROGRAM

Name of Dam:	Warrington Dam
County Located:	Bucks County
State Located:	Pennsylvania
Stream:	Little Neshaminy Creek
Coordinates:	Latitude 40° 13.6'
	Longitude 75° 9.6'
Date of Inspection:	23 April 1979

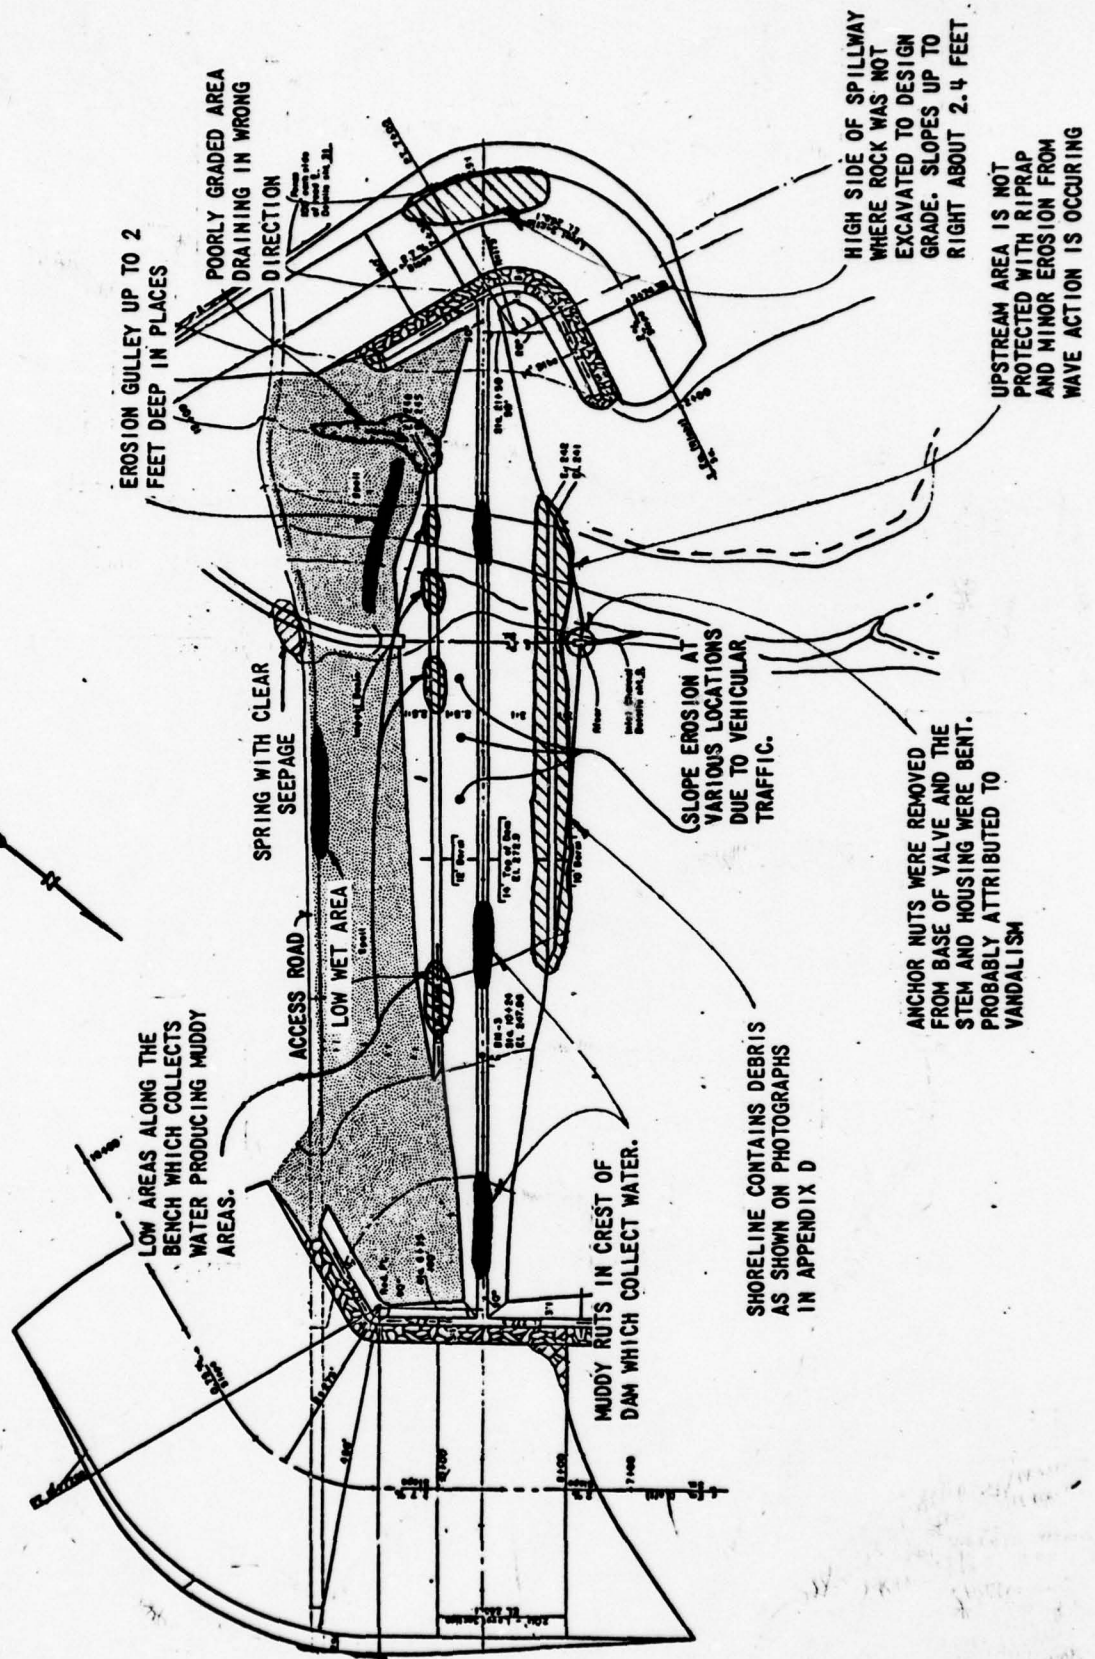
FIELD OBSERVATION PLAN
WARRINGTON DAM
SHEET 5A OF 11

Beyond the spoil area along the access road, a low wet area and spring were noted. Clear seepage from the spring was discharging into the spillway discharge channel. It was assessed that this spring and low wet area along the access road are probably associated with groundwater seepage as a result of storage behind the embankment and poor drainage, respectively. There was no evidence along the downstream toe of seepage through the embankment except for clear seepage discharging into the impact basin from the embankment drainage system.

The only seepage noted is shown on sheet 5a and is located downstream of the dam beyond the spoil area along an access road. This seepage was assessed to be associated with a localized rise of groundwater as a result of impoundment behind the dam.

As shown on Sheet 5a, wet areas and a spring were noted 120 to 150 feet downstream of the toe along an access road. These wet areas with clear flowing water are probably associated with the local rise in the groundwater. Very slight seepage upstream of impact basin, no erosion noted.

4. Seepage noted beyond the downstream toe should be monitored. If there is an increase in the seepage, appropriate remedial measures should be taken.

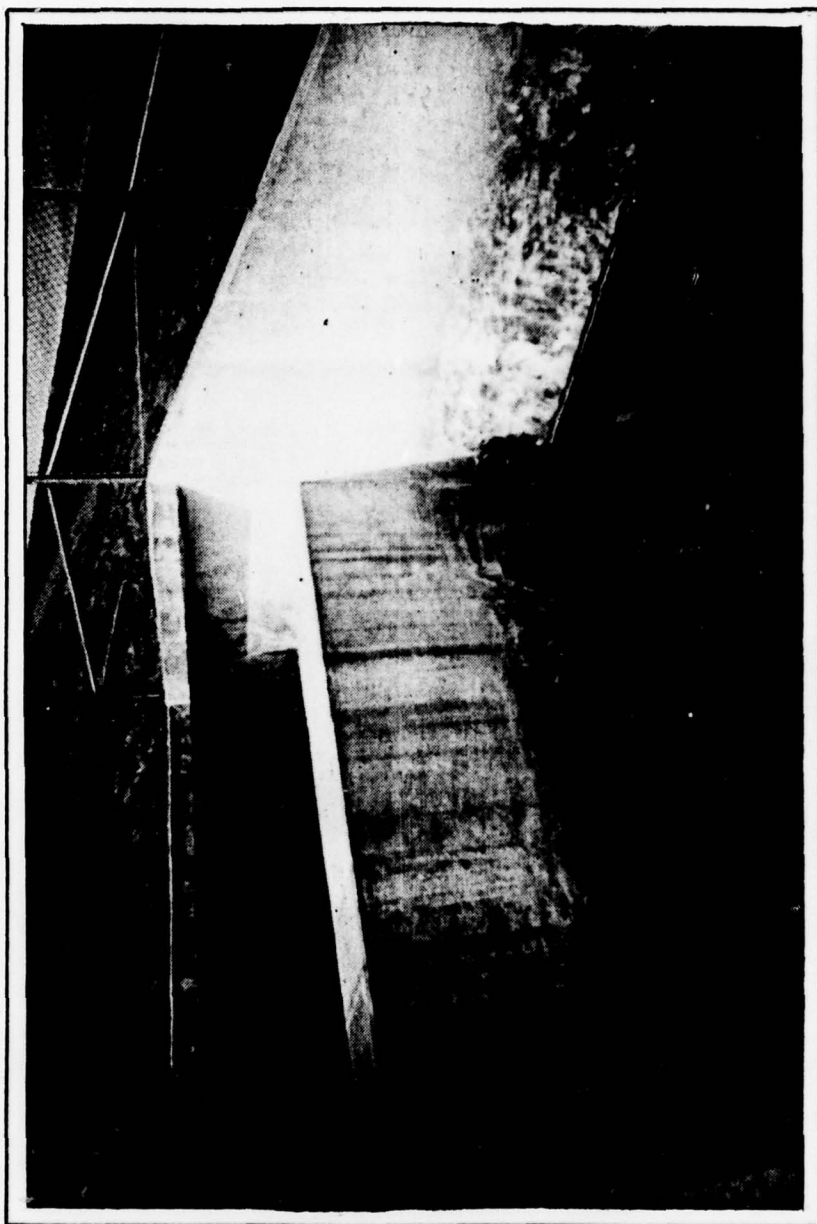
PHOTOGRAPH NO. 2

Embankment drain outlets were inspected at the impact basin. Clear seepage was flowing from the drains.

PRINCIPAL SPILLWAY IMPACT BASIN.

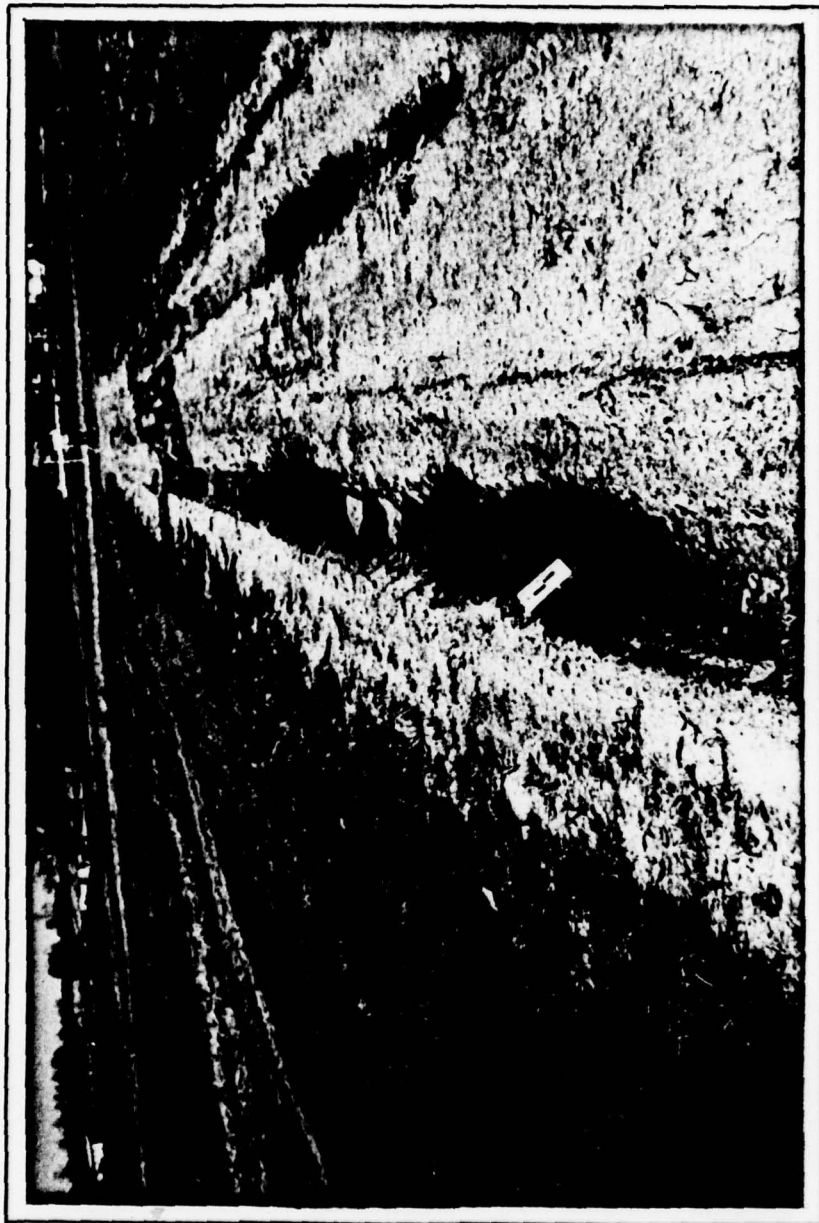
PHOTOGRAPH NO. 9

<u>VISUAL EXAMINATION OF</u>	<u>OBSERVATIONS</u>	<u>REMARKS OR RECOMMENDATIONS</u>
SURFACE CRACKS	None observed.	The crest is rutted and muddy in areas as a result of unauthorized vehicles.
UNUSUAL MOVEMENT OR CRACKING AT OR BEYOND THE TOE	None observed.	
SLOUGHING OR EROSION OF EMBANKMENT AND ABUTMENT SLOPES	No significant erosion observed on the embankment but as shown on Sheet 5a, substantial erosion was noted beyond the toe. Upstream slopes contain a lot of debris. See photographs.	
VERTICAL AND HORIZONTAL ALIGNMENT OF THE CREST	Alignment both vertically and laterally is good.	
RIPRAP FAILURES	None observed.	It is noted that the upstream is not protected with riprap and that some slope erosion is occurring.

VIEW OF CREST CONTAINING RUTS AND
STANDING WATER.

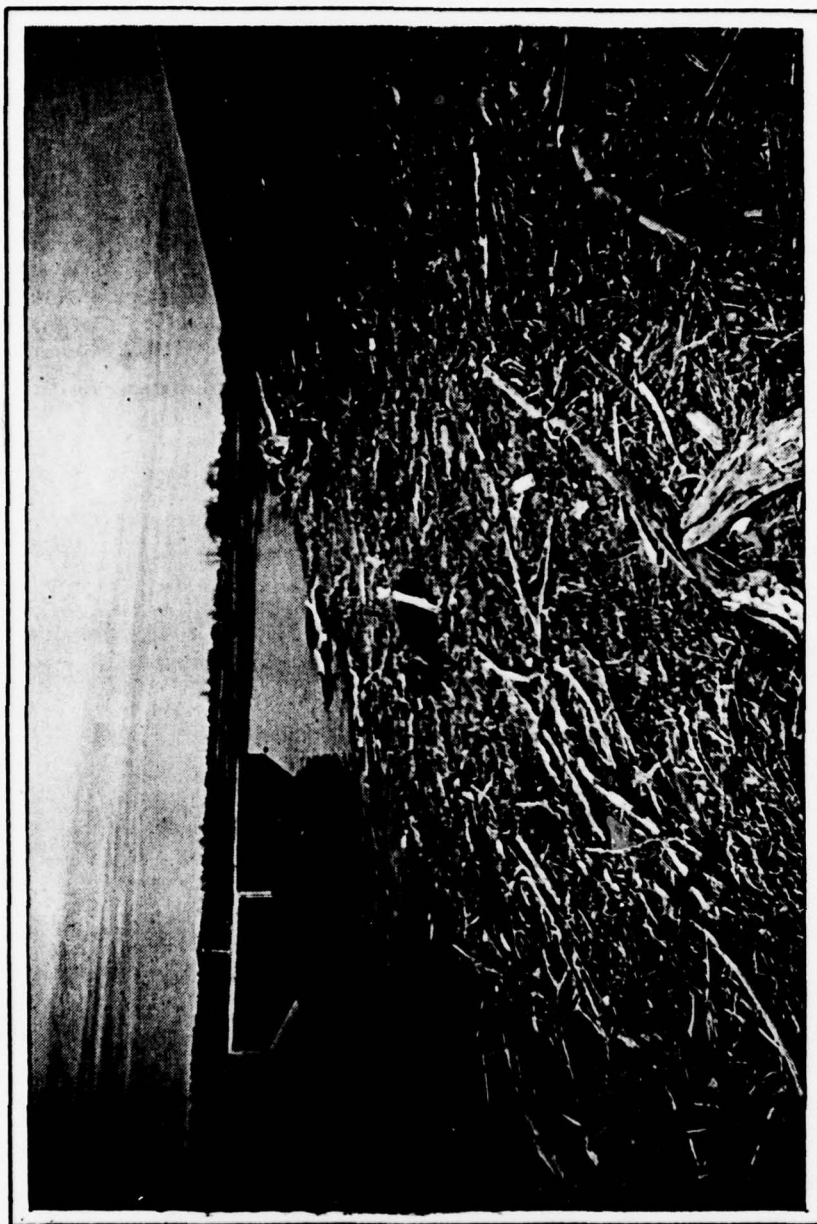
PHOTOGRAPH NO. 12

Debris was noted along the upstream slope of the dam, which is considered undesirable and could partially clog the principal spillway. Muddy areas, ruts, erosion, and general deterioration of both the upstream and downstream slopes and the benches were noted, predominantly as a result of unauthorized vehicular traffic across the dam and slopes.

DEBRIS ALONG UPSTREAM SLOPE.

1. Debris along the upstream slope and along the sides of the reservoir should be removed to minimize the potential for clogging the spillway intake system.
2. Erosion along the shoreline, if it continues to worsen, should be stabilized with designed riprap. Recommendations for this stabilization should be obtained from the Soil Conservation Service (SCS).
3. If at all possible, devices should be installed to discourage vehicular traffic along the crest and slopes of the embankment. Without this unauthorized traffic, the erosion, ruts and general deterioration of the slopes would have been minimal.
4. Erosion along the walls of the impact basin should be repaired.

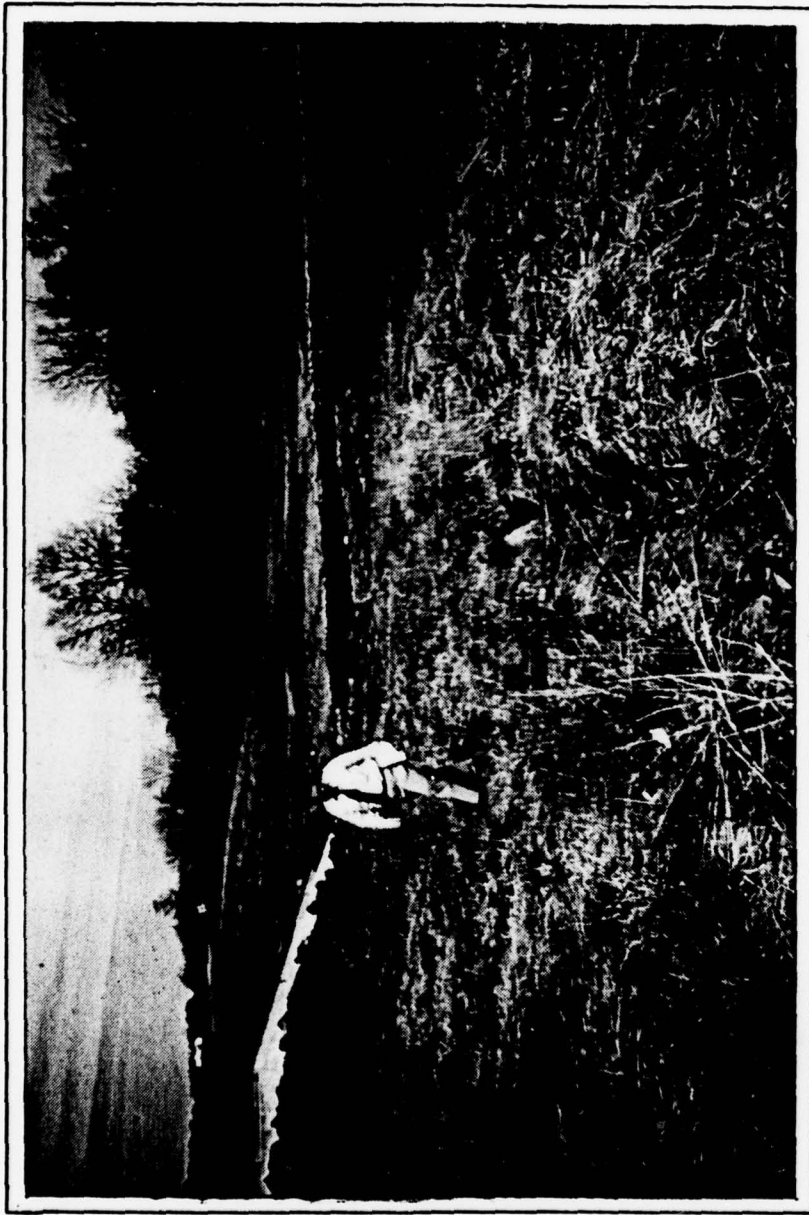
PHOTOGRAPH NO. 13

Beyond the toe in the spoil area, erosion gullies up to two feet deep were noted. These gullies drain towards the dam into a poorly drained area which produces a marshy condition.

EROSION GULLY ALONG DOWNSTREAM TOE
ON THE RIGHT SIDE OF THE IMPACT
BASIN.
